橋梁名	路線名	所在地	起点側	緯度	34° 5' 12"		
				経度	134° 27' 49"		
新栄橋 (フリガナ) シンエイバシ	町道桜間47号線	名西郡石井町高川原字桜間					
管理者名	点検実施年月日	路下条件	代替路の有無	自専道or一般道	緊急輸送道路	占用物件(名称)	
石井町	2016.9.14	河川	有	一般道	-	無

道路橋毎の健全性の診断(判定区分 I~IV)

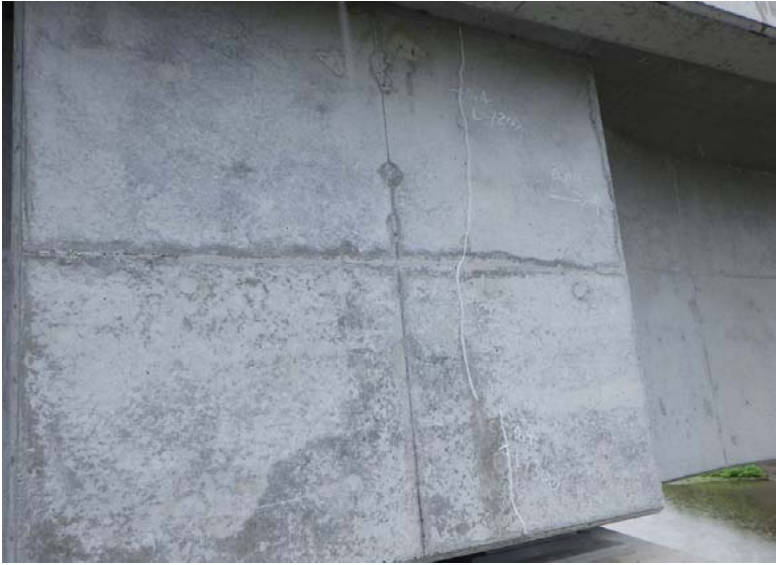
<p>上部構造(主桁01)【判定区分: Ⅱ】</p> <p>写真1</p>

点検者 (株)環境防災				点検責任者 梯 義文		
点検時に記録				措置後に記録		
部材名	判定区分 (I~IV)	変状の種類 (II以上の場合に記載)	備考(写真番号、位置等が分かるように記載)	措置後の判定区分	変状の種類	措置及び判定実施年月日
上部構造	主桁	II	ひびわれ、遊離石灰、剥離 写真1~3、主桁01,03			
	横桁	I				
	床版	I				
下部構造	II	ひびわれ	写真4,5、下部工01			
支承部	I					
その他	II	ひびわれ、欠損	写真6~8、地覆、排水管

点検時に記録		措置後に記録	
(判定区分) II	(所見等) 主桁に打継目からの遊離石灰、部分的な剥離、PC定着部にひびわれが見られる。下部構造にひびわれが見られる。	(再判定区分)	(再判定実施年月日)
