橋梁名	路線名	所在地	起点側	緯度	34° 5' 13"		
				経度	134° 27' 27"		
加茂野橋 (フリガナ) カモノハシ		町道加茂野52号線	名西郡石井町高川原字加茂野				
管理者名	点検実施年月日	路下条件	代替路の有無	自専道or一般道	緊急輸送道路	占用物件(名称)	
石井町	2016.9.15	河川	有	一般道	-	水道管

部材単位の診断(各部材毎に最悪値を記入)

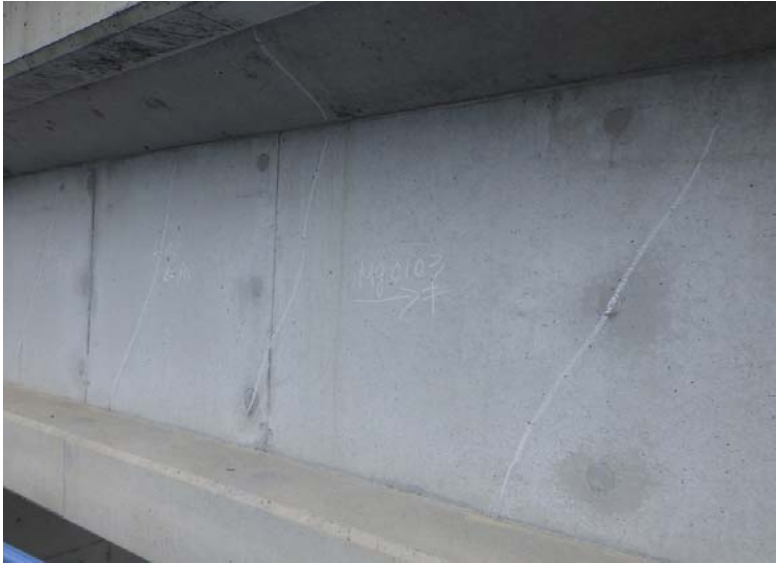
<p>上部構造(主桁01)【判定区分: Ⅱ】</p> <p>写真1</p>

点検者			(株)環境防災		点検責任者		梯 義文		
点検時に記録				措置後に記録					
部材名		判定区分 (I~IV)	変状の種類 (II以上の場合に記載)	備考(写真番号、位置等が分かるように記載)	措置後の判定区分	変状の種類		措置及び判定実施年月日	
上部構造	主桁	II	ひびわれ、剥離	写真1,2、主桁01					
	横桁	I							
	床版	II	床版ひびわれ	写真3、床版01					
下部構造		II	ひびわれ	写真4,5、下部工01,02					
支承部		I							
その他		II	ひびわれ、欠損	写真6~8、地覆、伸縮装置

点検時に記録			措置後に記録		
(判定区分)	(所見等)	主桁、下部構造に部分的なひびわれ、また床版に遊離石灰を伴うひびわれが見られる。主桁に部分的な剥離が見られる。	(再判定区分)	(再判定実施年月日)	
II
